RAILROAD ACCIDENT REPORT

DERAILMENT OF AMTRAK TRAIN 21 ON THE UNION
PACIFIC RAILROAD AT ARLINGTON, TEXAS
DECEMBER 20, 1998

**NTSB/RAR-01/02
PB2001-916302
Notation 7159A
Adopted July 24, 2001**

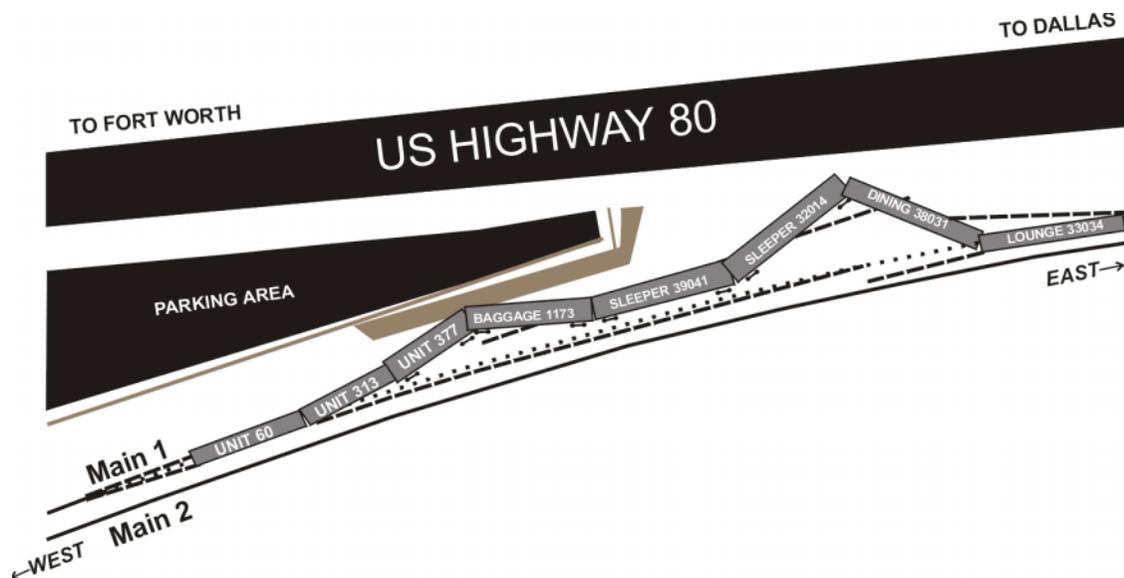
Figure 2. Accident scene. Units 60, 313, and 377 are the locomotives of Amtrak train No. 21.

All 3 locomotives and 6 of the 10 cars of Amtrak train 21 derailed. The lead and second locomotives remained upright and aligned with the track. The third locomotive and the first four cars turned at different angles to the track and fell on their sides to the north side of the track, at the edge of a drainage ditch just 15 to 20 feet south of U.S. Highway 180. The fuel tank of the third locomotive ruptured, spilling approximately 600 gallons of fuel onto the ground. The fifth and sixth cars derailed but remained upright and essentially aligned with the track. The remaining four cars did not derail and were not damaged.
